### AS FOUND REPORT WITH RECOMMENDED REPAIR

ITT PRO SERVICE CENTERS  
MULTI-STAGE HORIZONTAL SPLIT CASE DIFFUSER PUMP

JOB #:	79798	CUSTOMER:	CAC
DATE:	May 4/2016	INSPECTED BY:	Jeff Rich
<b>PUMP DATA</b>			
MFG.:		MODEL:	
SIZE:		# OF STAGES:	
<b>DISASSEMBLY</b>		<b>CASE INSPECTION</b>	
Suction nozzle coated in scale			
What is the condition of the parting face:		Good	
<u>Warpage</u> when checked with straight edge:			
<b>Mic All Bore Sizes:</b>			
Stuffing Box Thrust End At Mechanical Seal Register:	3.998"	Stuffing Box Coupling End At Mech Seal Register:	3.997"
Thrust End Seal Gland Register OD:	3.990"	Coupling End Seal Gland Register OD:	3.992"
Clearance:	0.008"	Clearance:	0.005"
Throttle Bushing Fits Cplg End:	3.238"	Throttle Bushing Fit Thrust End:	3.347"
<b>Diffuser/Channel Ring Fits:</b>			
STAGE		STAGE	
1	5.246"	7	5.249"
2	5.237"	8	5.247"
3	5.245"	9	5.753"
4	5.248"	10	
5	5.250"	11	
6	5.243"	12	
Make Bushings for Boring Bar and Check Bore for <u>Runout</u> :	<input type="checkbox"/>	GOOD	<input type="checkbox"/> BAD
Check all bores, including stuffing boxes for any signs of washing or cracking. Any suspicious signs?

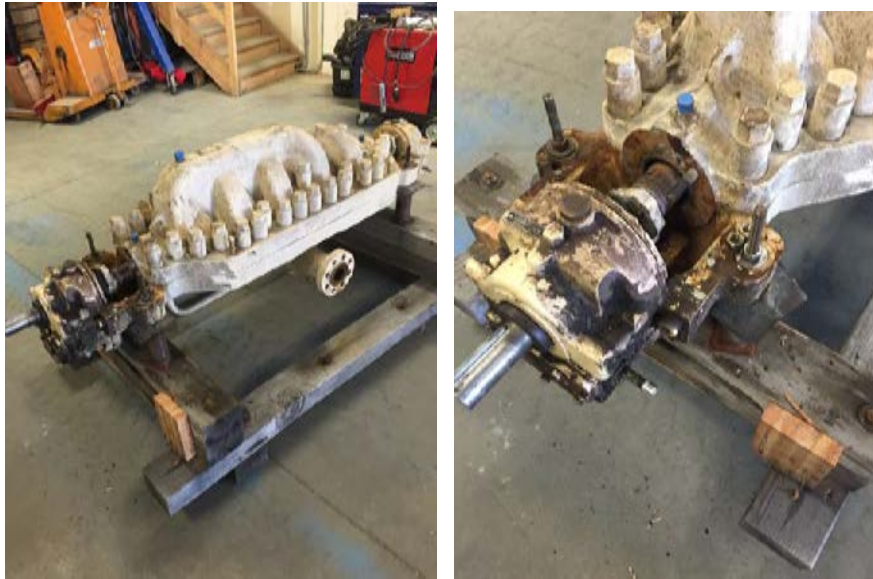
#### Pump as received

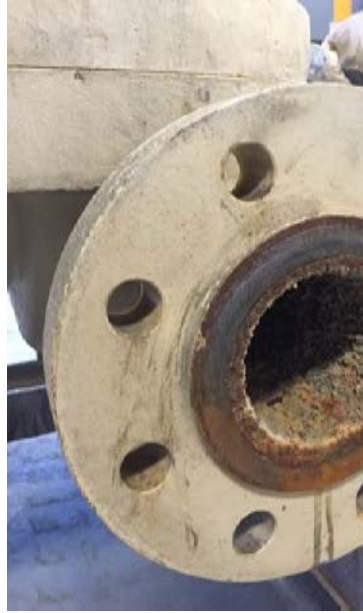
Scale in suction nozzle

If so, what are their sizes?			
Are all the studs and cap nuts in good reusable condition?			Yes
If not, list description of what is needed. Sizes, threads per inch, lengths and quantity.			
Are there any broken bolts or studs that need to be removed?			NO
Does the case need reboring? If yes, why?		Yes, Casing fits are worn	
COMMENTS: Site should look into reasons on why foreign object would be getting into the Suction of the pump.

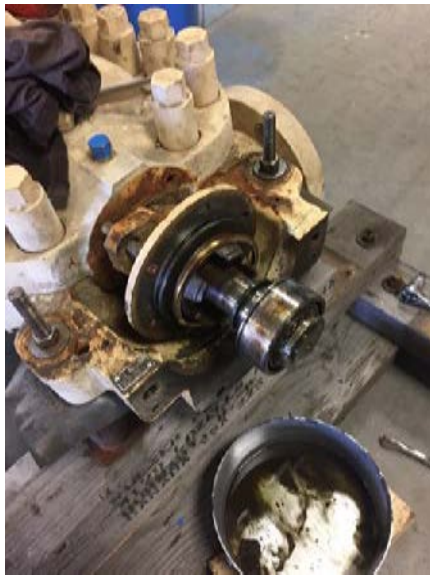
Damaged Thrust Bearing

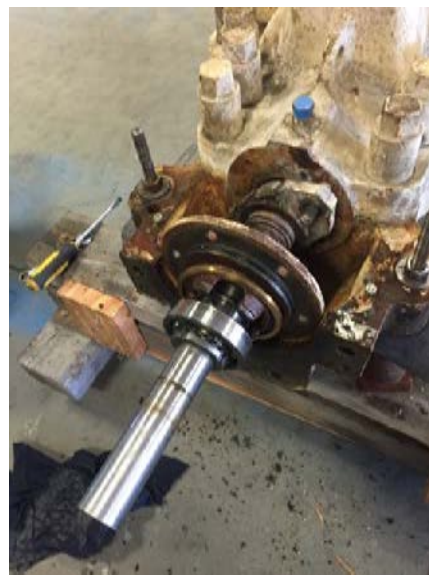
Radial Bearing

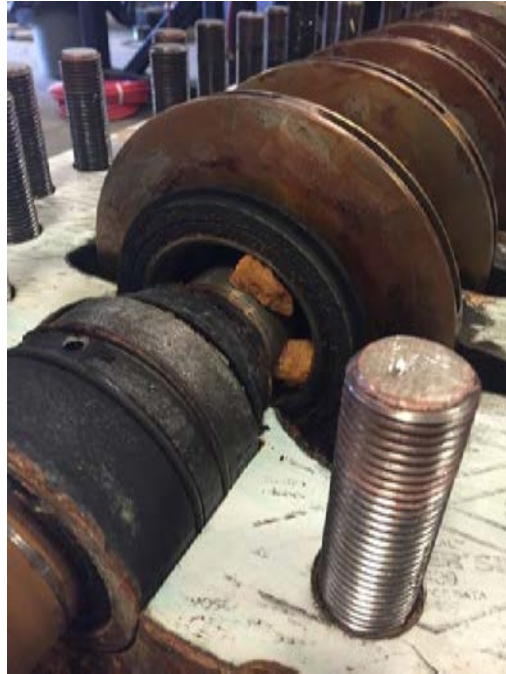
- 1) Casing will need to be line bored to restor all internal fits.
- 2) Foreign objects were found in the 1<sup>st</sup> stage impeller. The first stage impeller was cracked in 4 places.
- 3) 8<sup>th</sup> stage casing wear ring was broken in half and parts were not in the pump casing. 8<sup>th</sup> stage impeller wear ring was missing.

Debris in 1<sup>ST</sup> stage suction impeller

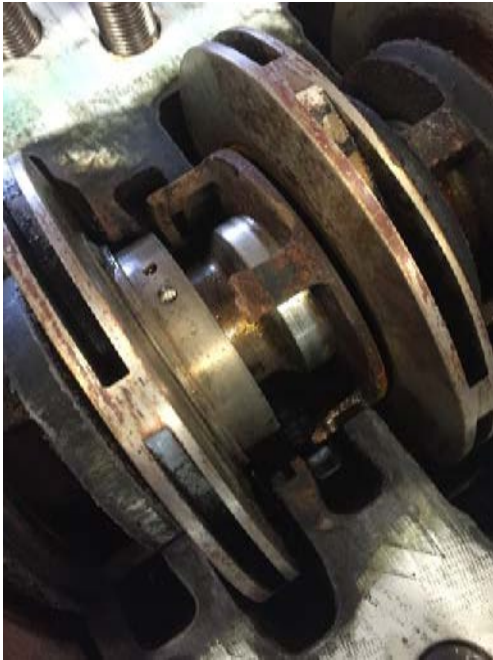
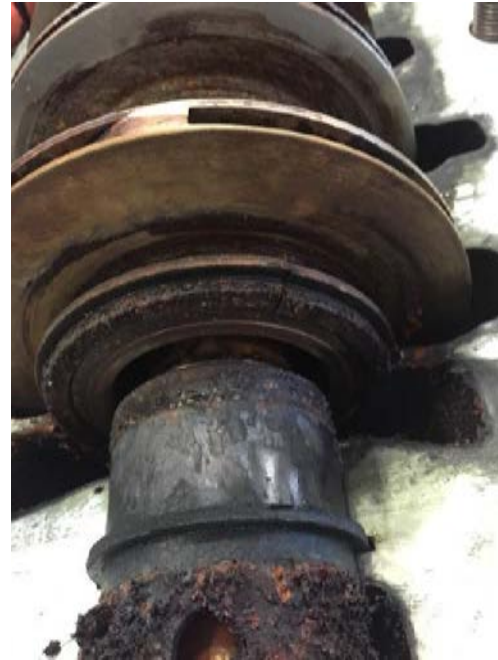
Broken casing wear ring and damaged impeller wear ring

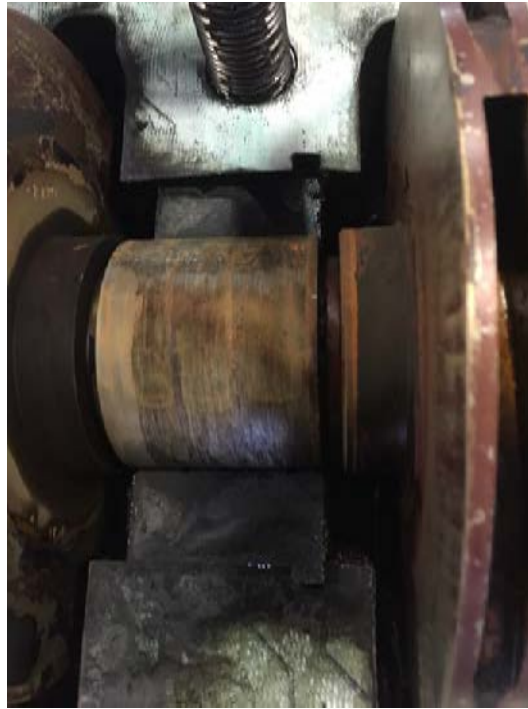
Worn center bushing

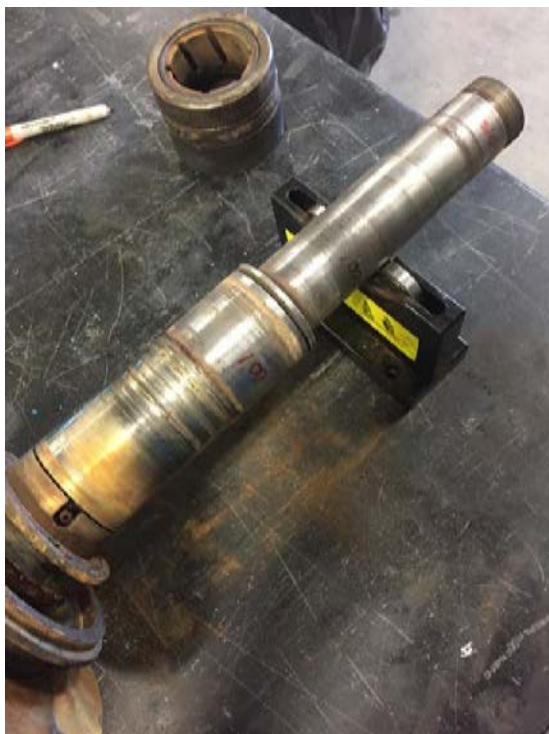
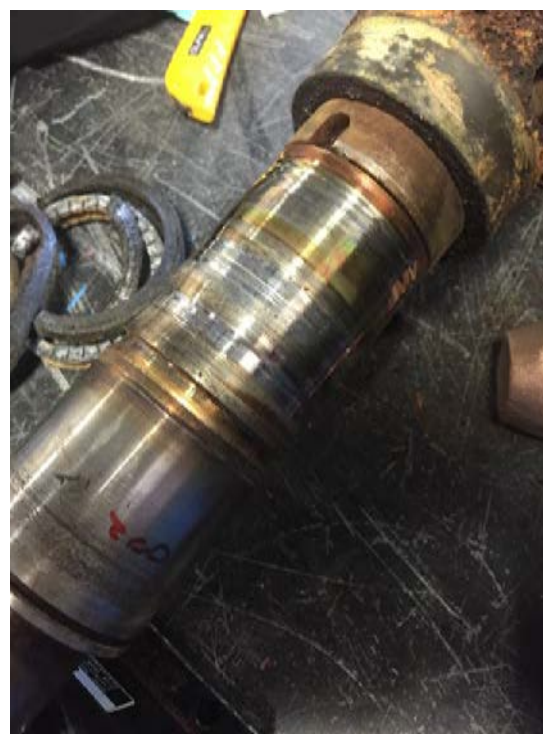
Worn packing wear sleeve

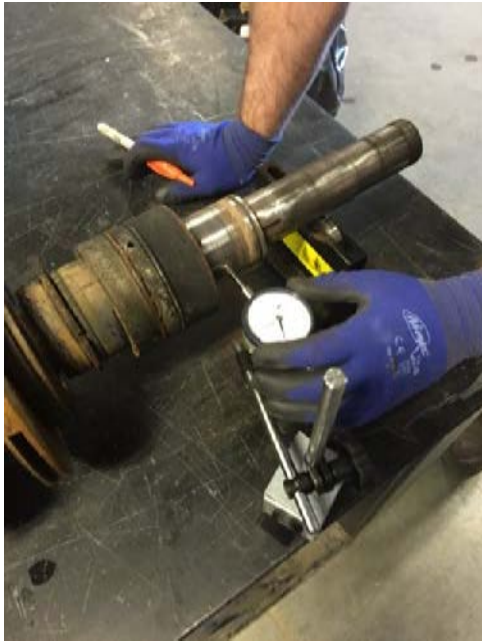
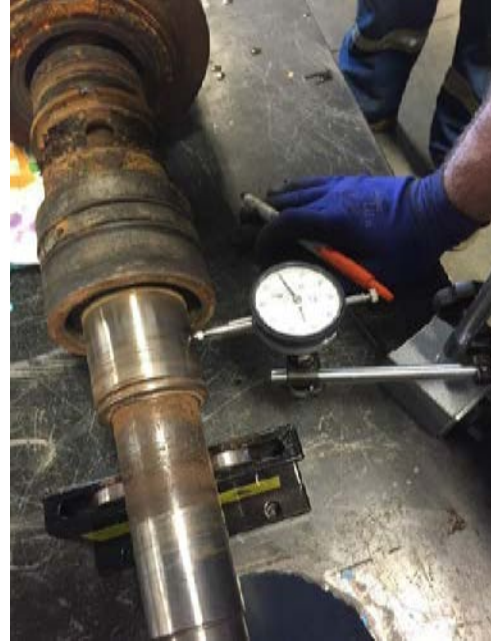
Run out check 0.0015" – 0.002"

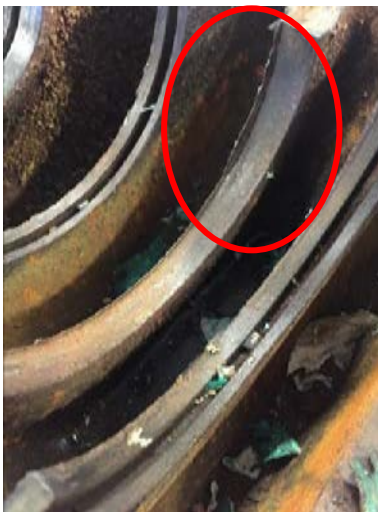
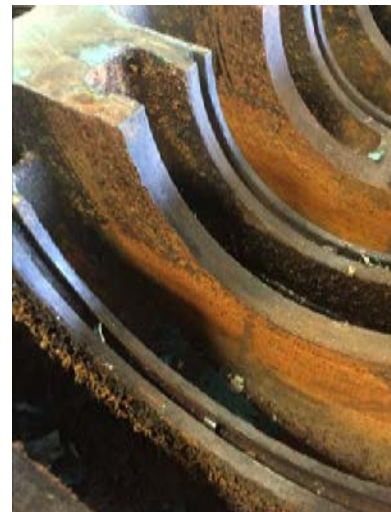
Worn pump housing from 1<sup>ST</sup> stage impeller

- Weld repair casing at areas of high wear
  - Machine both split line gasket faces
  - Line bore all internal fits to original spec
  - Tap all holes
  - Debur all fits and grooves
  - Clean all passages
  - Manufacture new split line gasket using specified materials (0.015" thickness)
  - Install case studs and tighten
-

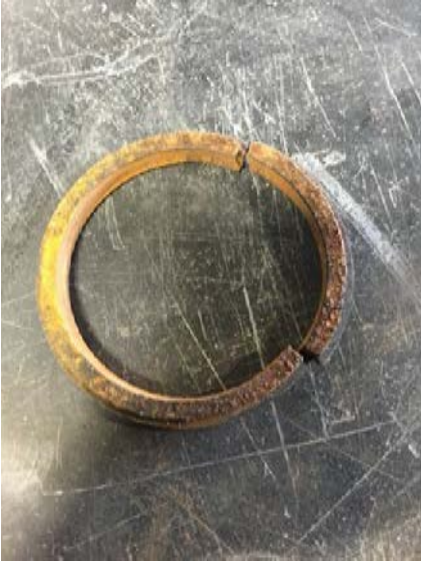
#### **CASING RINGS-HUB SIDE**

All case hub rings are worn and require replacement

**Bores are worn from contact with impellers**

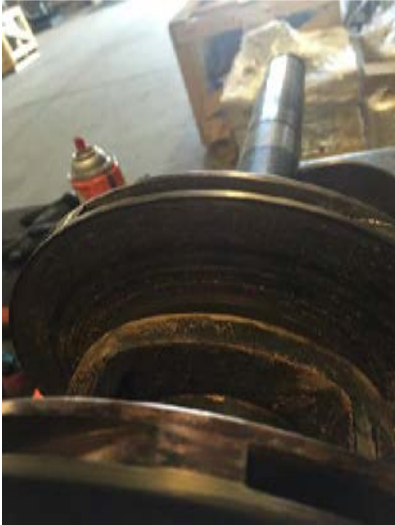
Wear on backside

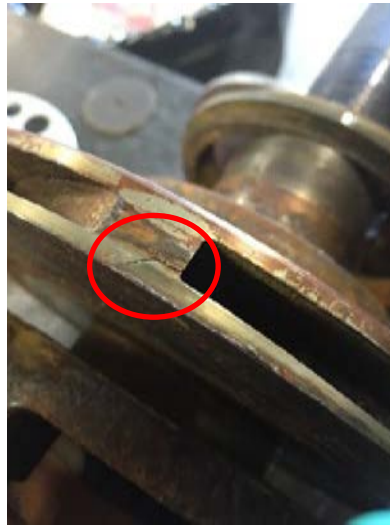
- Wear on the back side
- 1<sup>st</sup> stage impeller cracked in 4 places and will need to be replaced.

Cracked

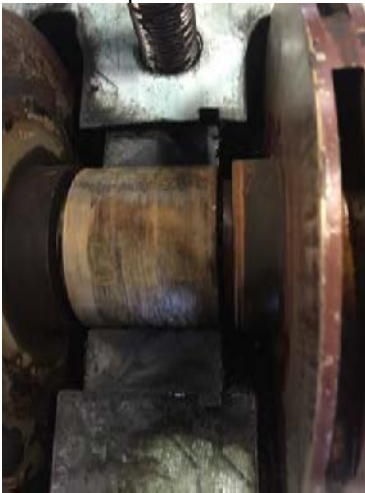
## CENTER BUSHING

**Bore is worn and all outside dia's are out of round**

- Replace with new.

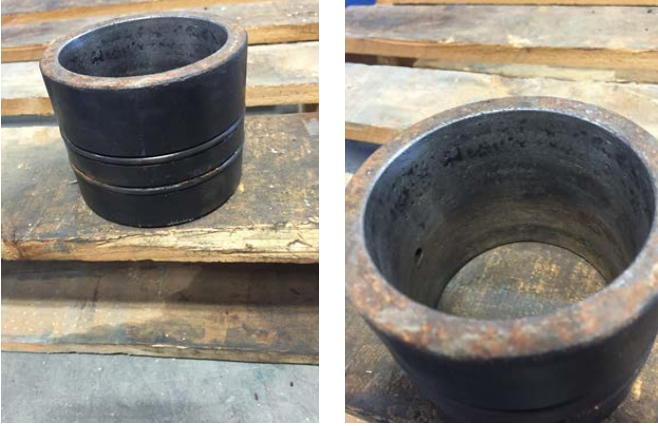
## STUFFING BOX BUSHINGS

**Bores worn over spec**

Replace with new

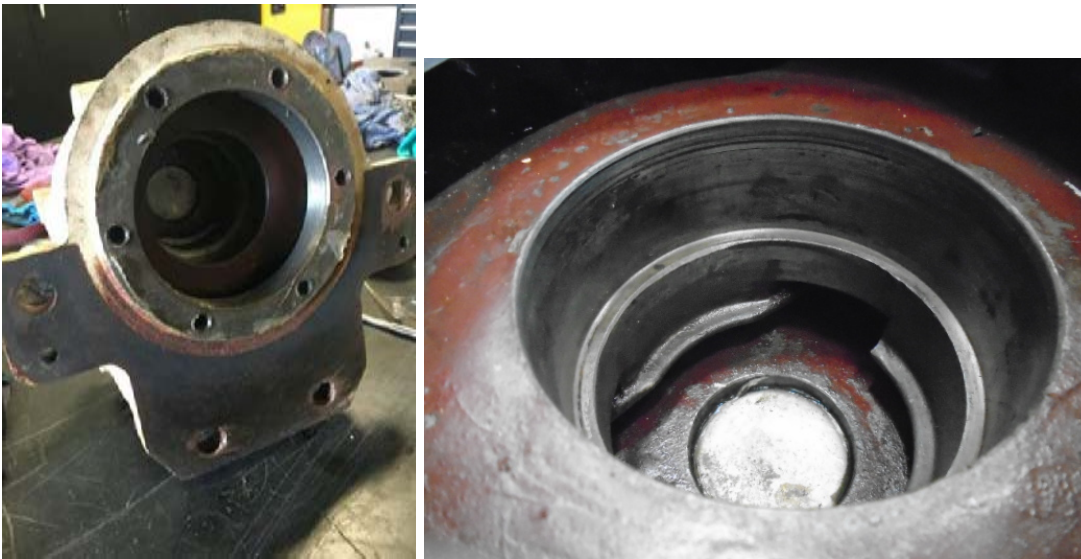
**Bearing housing bores are worn over spec. Peening marks visible from previous repair.**

- Hone faces
- Clean I.D.'s and coat non machine areas with insulating varnish
- Over bore, insert and machine to spec.

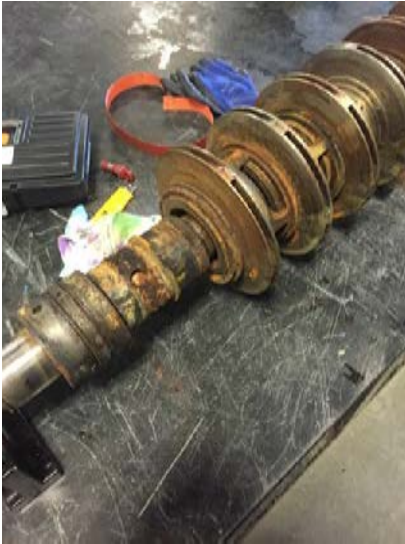
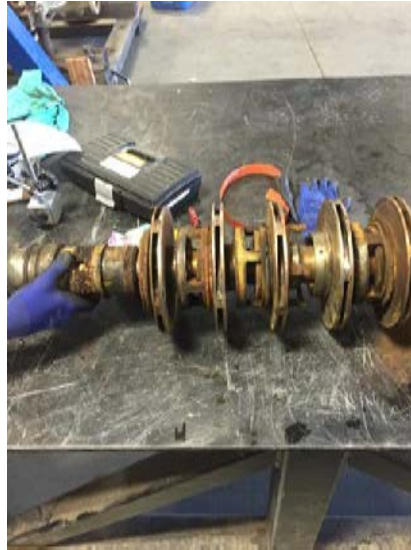
**Rotor prior to removing impellers**

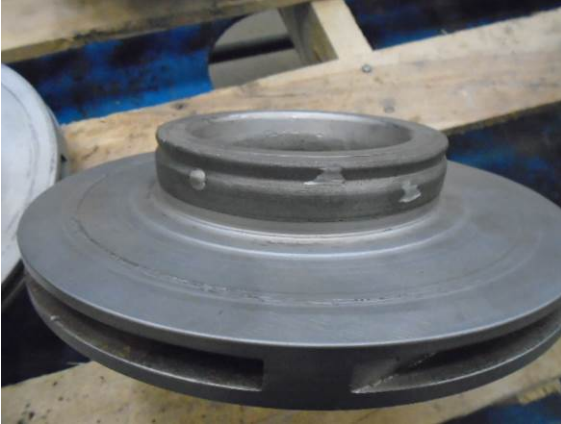
Impeller wear rings are worn.

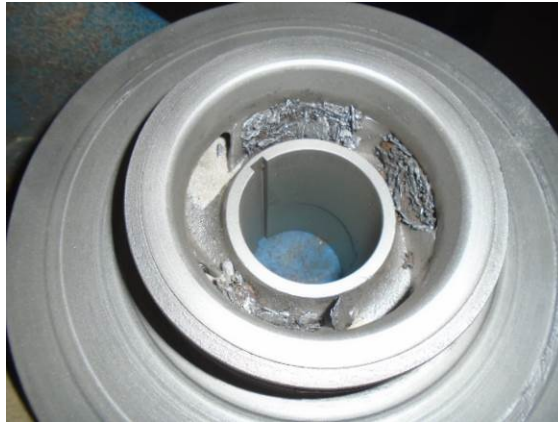
Debris lodged in impeller vanes

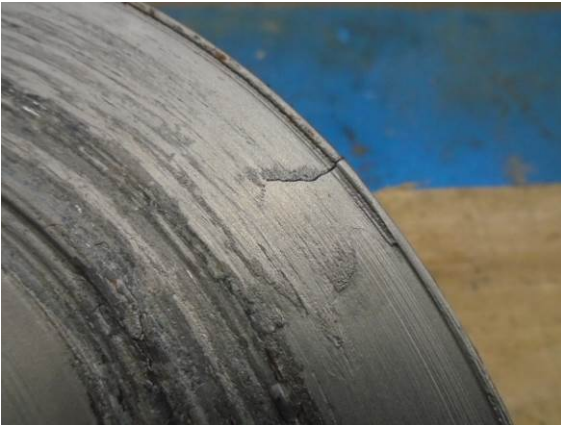
Cracked impeller shroud.
