### AS FOUND REPORT WITH RECOMMENDED REPAIR

ITT PRO SERVICE CENTERS  
MULTI-STAGE HORIZONTAL SPLIT CASE DIFFUSER PUMP

JOB #:	79798	CUSTOMER:	CAC
DATE:	May 4/2016	INSPECTED BY:	Jeff Rich
<b>PUMP DATA</b>			
MFG.:		MODEL:	
SIZE:		# OF STAGES:	
<b>DISASSEMBLY</b>		<b>CASE INSPECTION</b>	
Suction nozzle coated in scale			
What is the condition of the parting face:		Good	
<u>Warpage</u> when checked with straight edge:			
<b>Mic All Bore Sizes:</b>			
Stuffing Box Thrust End At Mechanical Seal Register:	3.998"	Stuffing Box Coupling End At Mech Seal Register:	3.997"
Thrust End Seal Gland Register OD:	3.990"	Coupling End Seal Gland Register OD:	3.992"
Clearance:	0.008"	Clearance:	0.005"
Throttle Bushing Fits Cplg End:	3.238"	Throttle Bushing Fit Thrust End:	3.347"
<b>Diffuser/Channel Ring Fits:</b>			
STAGE		STAGE	
1	5.246"	7	5.249"
2	5.237"	8	5.247"
3	5.245"	9	5.753"
4	5.248"	10	
5	5.250"	11	
6	5.243"	12	
Make Bushings for Boring Bar and Check Bore for <u>Runout</u> :	<input type="checkbox"/>	GOOD	<input type="checkbox"/> BAD
Check all bores, including stuffing boxes for any signs of washing or cracking. Any suspicious signs?

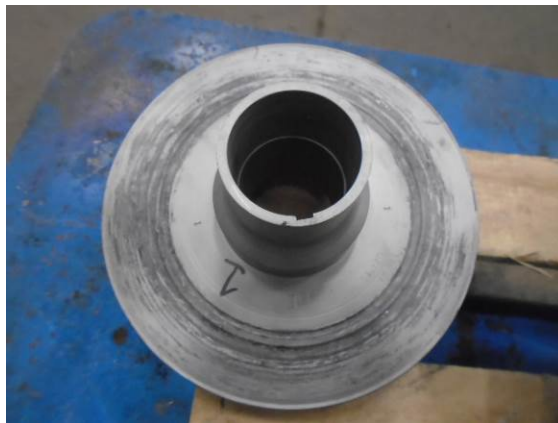
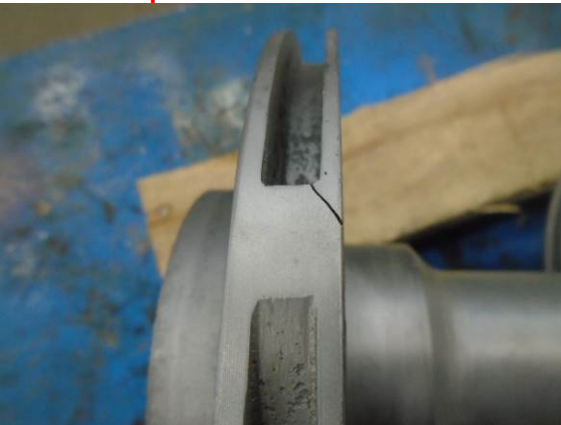
- Wear on the back side
- 1<sup>st</sup> stage impeller cracked in 4 places and will need to be replaced.

Cracked impeller shroud.

- Replace with new.
